Marshland Rescue Provides Valuable Lessons

BY JACK FLYNN AND JERRY KNAPP

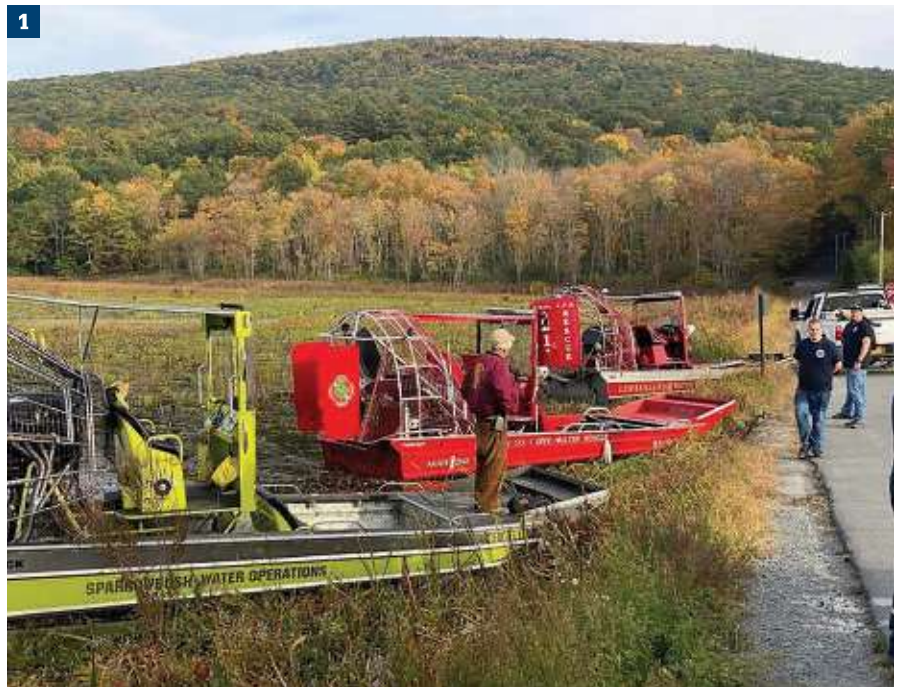
(1) Airboats had to be dropped into the marsh after being unloaded on pavement. (Photo by Jack Flynn.)

This rescue was complicated from start to finish. The New York State Department of Environmental Conservation (DEC) has banned powered boats (with the exception of electric motors) from the wetlands because there are no launch sites available except those for small, trailered boats, rafts, and kayaks. This made launching even Sparrowbush's airboat difficult; it had to be off-loaded on a paved highway and then dropped over an embankment into the wetlands.

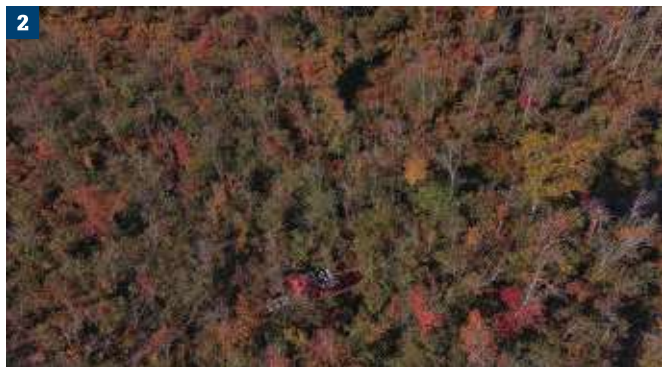
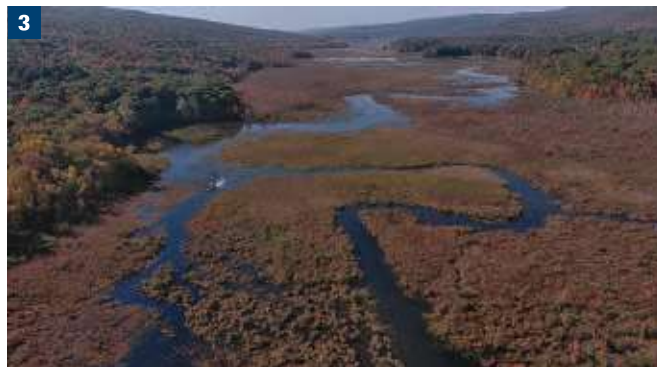
(2, 3) First-due rescuers became lost in the featureless wetland and stuck on difficult vegetation. (Photos courtesy of the New York State Department of Conservation.)

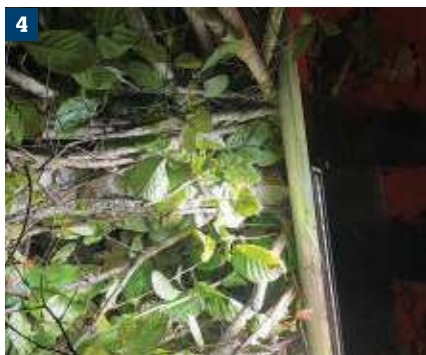
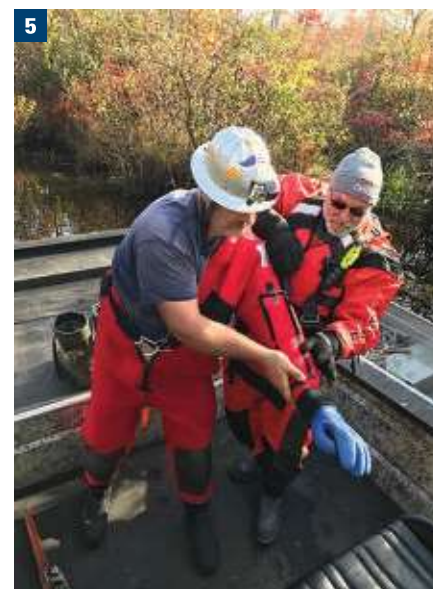
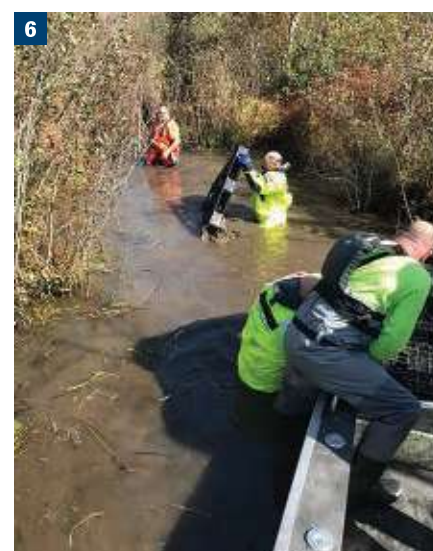
(4) The sides of the airboat were wedged between stubborn brush, causing it to become stuck. (Photo by Jack Flynn.) **(5)** Rescuers prepare to enter the marshland to retrieve the stranded airboat. (Photo by Jack Flynn.) **(6)** Crews attempt to use plastic pallets to place under the stuck airboat. (Photo by Jack Flynn.)

Since there was no way forward for the stuck airboat, it was decided to somehow lift the airboat and spin it on its axis to eventually work its way out with a tow rope using the most thrust the props could muster. Crews cut this heavy brush and moved tons of mud/muck and several grass hammock clumps. Although this sounds simple, members were up to their waists in mud and water, making moving around nearly impossible.

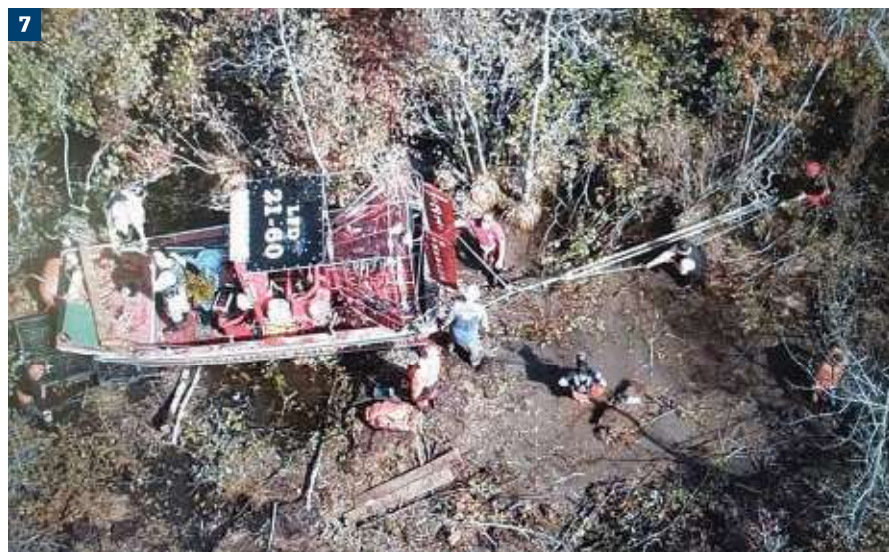
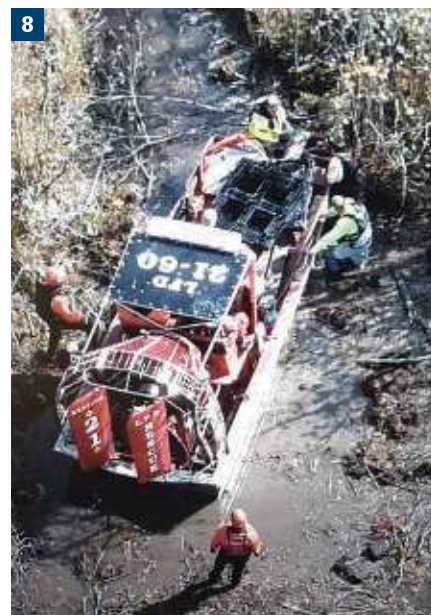
(7, 8) Crews worked in difficult conditions, finally using a haul system to free the airboat. (Photos courtesy of the New York State Department of Conservation.)

After six hours of members cutting heavy brush, moving muck, pushing, and tugging with ropes, the boat came free! Although the boat was rooted in the mud at the bottom, wind and water currents moved and pushed the semi-floating vegetation around, creating maze-like conditions that can constantly change.

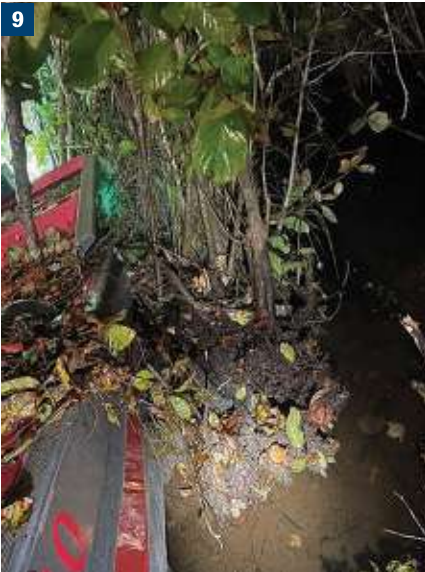
(9) The boat was wedged against numerous plants that were about one to two inches in diameter. (Photo courtesy of the New York State Department of Conservation.)
